Errata
MSP430F5524 Microcontroller

This document describes the known exceptions to the functional specifications (advisories).

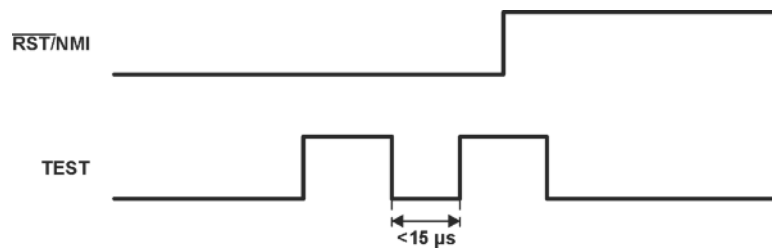
Description The BSL entry sequence requires that the low phase of the TEST/SBWTCK pin does not exceed 15us. This timing requirement is faster than most PC serial ports can provide, as shown in the following picture. If this requirement is not met, the entry sequence fails and the SYSBSLIND is not set.

Workaround An external hardware solution is recommended to provide the appropriate BSL entry sequence. See [http://processors.wiki.ti.com/index.php/BSL_\(MSP430\)](http://processors.wiki.ti.com/index.php/BSL_(MSP430)) for recommendations on available BSL hardware.
