Errata

TMS320C2834x Delfino MCUs Silicon Revision 0

This document describes the silicon updates to the functional specifications for the TMS320C2834x microcontrollers (MCUs).

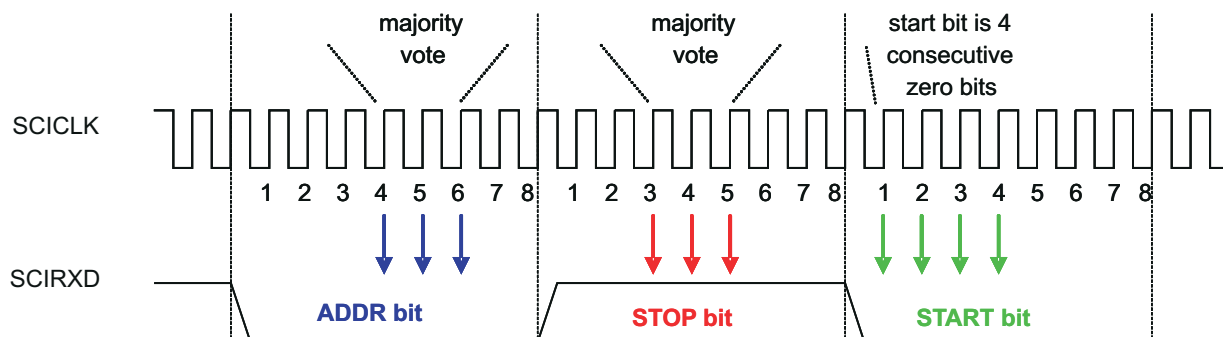
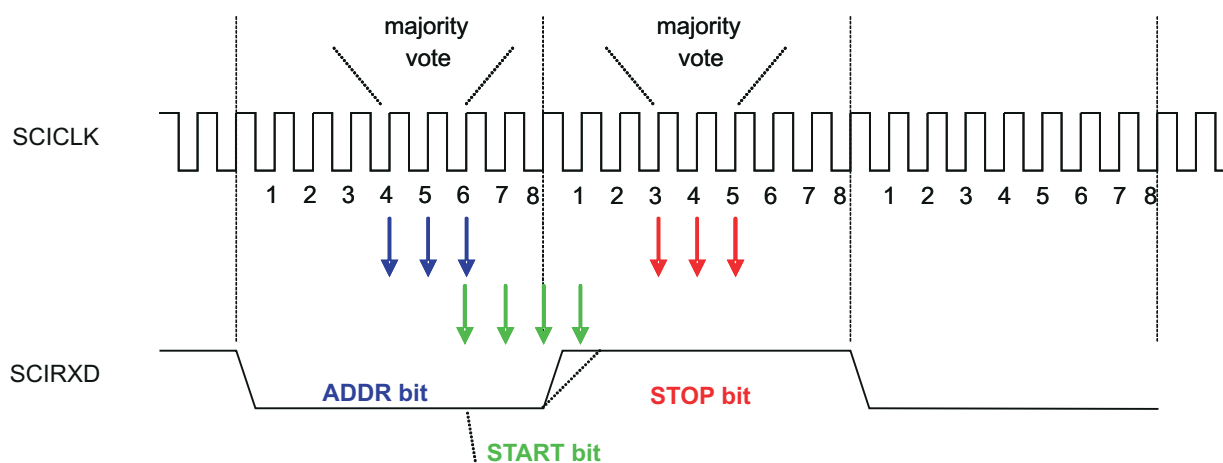
Figure 4-1. Difference Between Expected and Erroneous Operation of START Bit

Details SCI does not look for STOP bit after the ADDR bit. Instead, SCI starts looking for the start bit beginning on sub-sample 6 of the ADDR bit. Slow rise-time from ADDR to STOP bit can cause the false START bit to occur since the 4th sub-sample for the start bit may be sensed low.

Expected Operation:

Erroneous Operation:

Program the baud rate of the SCI to be slightly slower than the actual. This will cause the 4th sub-sample of the false START bit to be delayed in time, and therefore occur more towards the middle of the STOP bit (away from the signal transition region). The amount of baud slowing needed depends on the rise-time of the signal in the system. Alternatively, IDLE mode of the SCI module may be used, if applicable.
