High speed CAN transceiver with Partial Networking

This document provides additional information for the TLE9255WLC, TLE9255WSK and TLT9255WLC. This document relates to the following datasheets:

- TLE9255W datasheet Rev. 1.03 (TLE9255WLC, TLE9255WSK).
- TLT9255WLC datasheet Rev. 1.00.

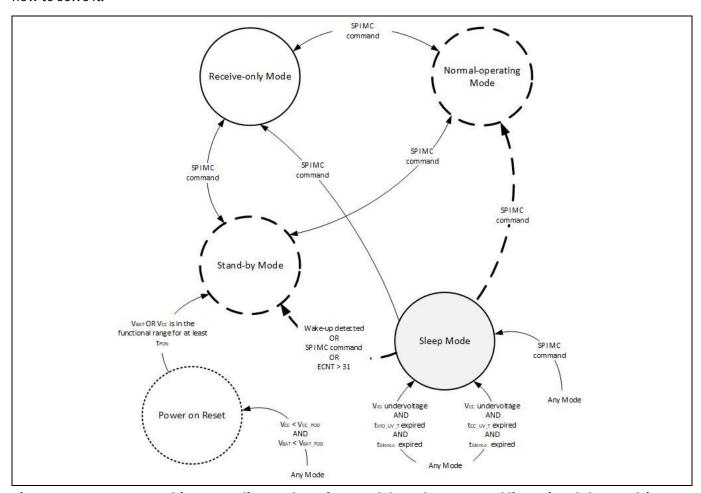
During Sleep mode, if a SPI-driven wake-up command is sent by the host at the same time as a WUF is detected, the transceiver's SPI registers may signal the state "normal" whereas the state machine has transitioned to standby mode. In standby, CAN Bus transmission is disabled, so if the controller triggers a CAN message the message is not transferred to the Bus. Figure 1 illustrates the situation: the dotted lines show the SPI command to switch to normal mode or the detected WUF which leads to a state change to standby mode.

Figure 1 State machine according to the referenced data sheet. Dotted lines signal the SPI driven state change and the WUF driven state change.

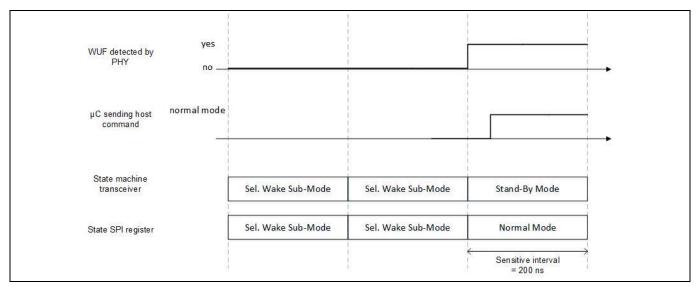
The state change from Selective Wake Sub-Mode to normal mode is issued via SPI command. If a WUF is detected within the same 200 ns clock cycle where the SPI frame is finished (CSN high), the device does not change to normal mode as requested via SPI but changes to standby mode as requested by the WUF. This behavior is correct.

However, in this case, the MODE_CTRL register does not indicate the correct mode of standby. Instead the mode is indicated as Normal, as issued by the SPI command but not successfully finished. If a microcontroller reads the status information from the SPI register, MODE_CTRL defines the state as "normal mode", but the transceiver's internal state machine is in standby mode. Figure 2 shows a timing diagram illustrating the situation.

Figure 2 WUF detected in same interval as SPI command, race condition happens.

Even though the described behavior is very unlikely to happen, to avoid such a race condition, two possible workarounds are described in chapter 2.

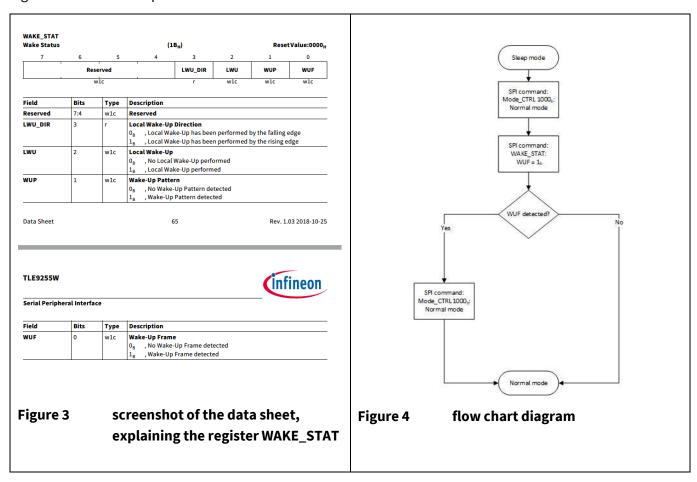
In case the state change to normal mode shall be initiated by a SPI command, one solution to avoid the negative consequence of a race condition would be to check the status of the register *Wake Status* WAKE_STAT (1B_H). This register includes the information whether a WUF was detected or not (see Figure 3).

If the value of the field WUF is equal to 1_B , the above described scenario may have happened. It is therefore recommended to send the SPI command for switching to normal mode a 2^{nd} time. If the device is already in normal mode, another mode switching command will not effect the behavior of the device. If the device is not yet in normal mode but in standby mode, issuing the command again triggers a state change to normal mode. Figure 4 illustrates this process.
